VOLUME III: CHAPTERS 6.7 - 6.12

The Naugatuck Valley Community College (Naugatuck) Energy Master Plan aims to identify ways Naugatuck can improve energy use on campus, and be an active participant in Connecticut State Colleges & Universities (CSCU)'s energy management, reduction and conservation efforts. The utility data received indicates Naugatuck is a higher energy use intensity (EUI) campus of the CSCU from an energy perspective (see Figure 1 Naugatuck Valley Energy Dashboard). The EUI method is used for benchmarking and comparison purposes. Energy management efforts in the past have reduced Naugatuck' energy use, through efforts such as de-lamping lighting fixtures and drive upgrades at the Core heating plant.

As part of the CSCU Energy Master Plan, Naugatuck's building infrastructure, energy use and energy management practices were assessed. The ultimate goal was to determine ways Naugatuck could improve its energy use on campus, and be an active participant in CSCU energy reduction efforts. This chapter identifies Naugatuck's historical energy use, future projected needs and energy recommendations.

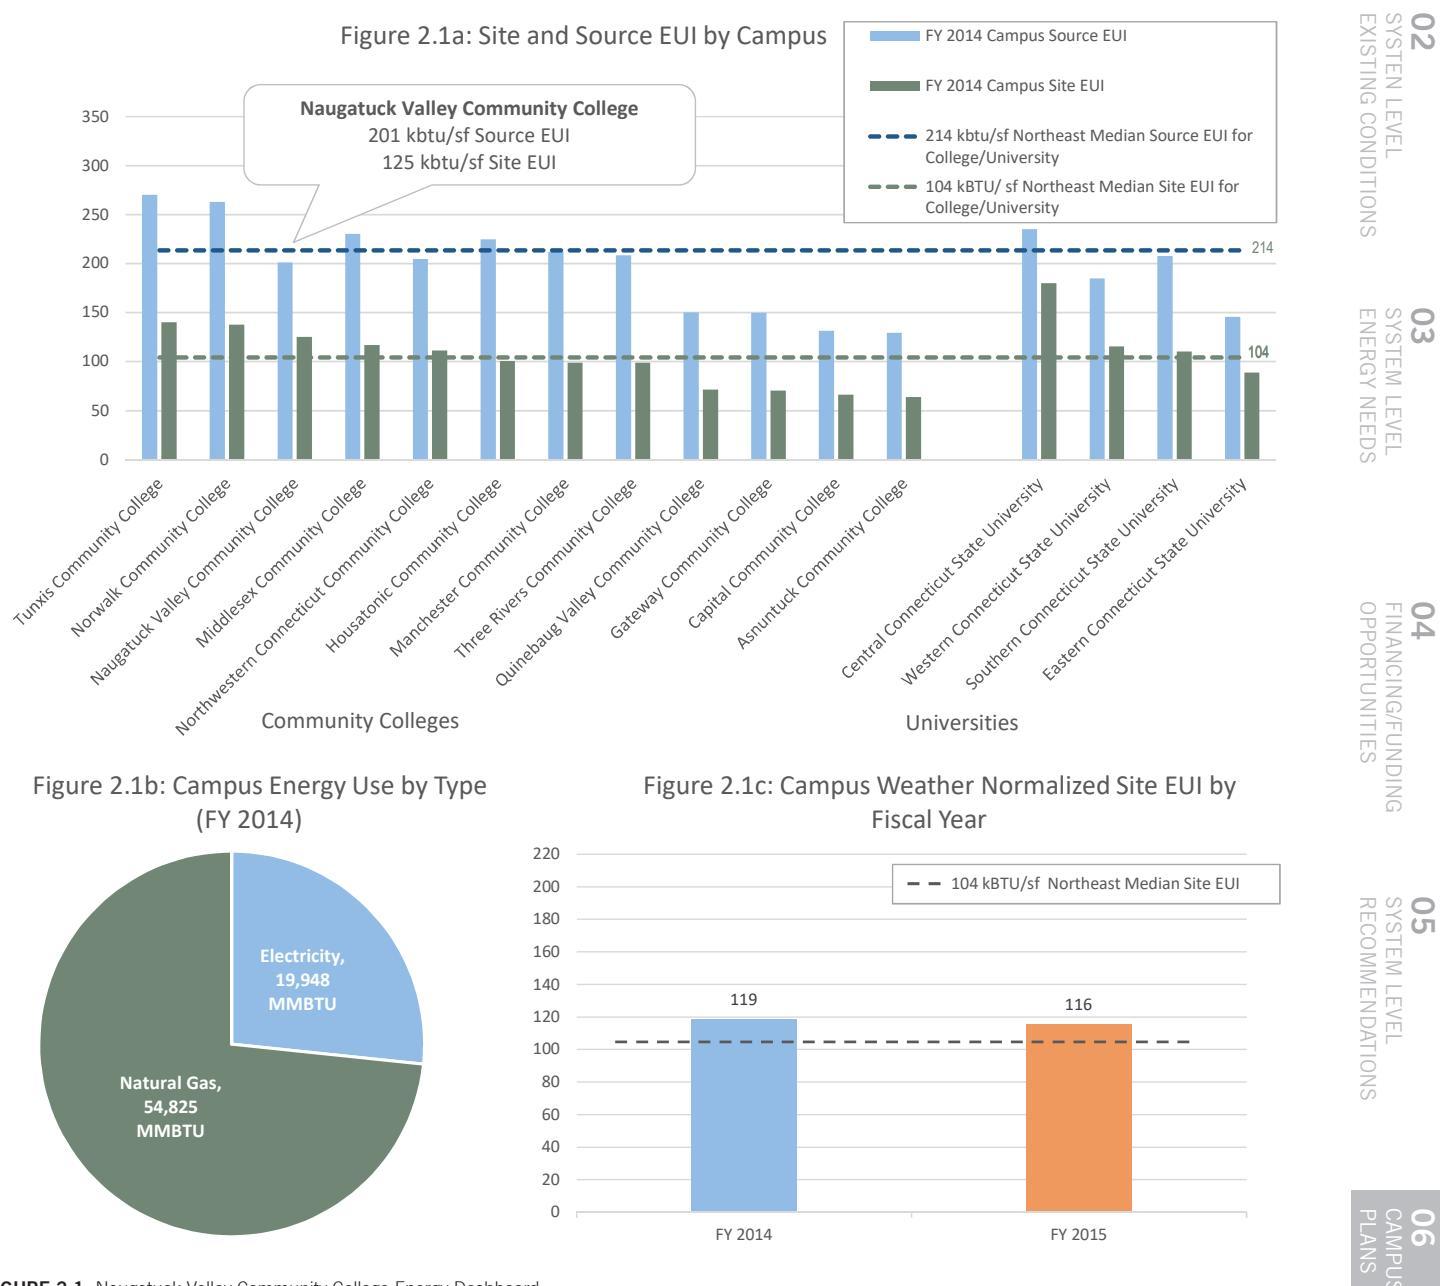
FIGURE 2.1: Naugatuck Valley Community College Energy Dashboard

Naugatuck's energy dashboard provides a summary of the campus' energy consumption, based on fiscal year 2014 and 2015 data. Appendix A documents information on the assumptions and data sources used for energy benchmarking purposes.

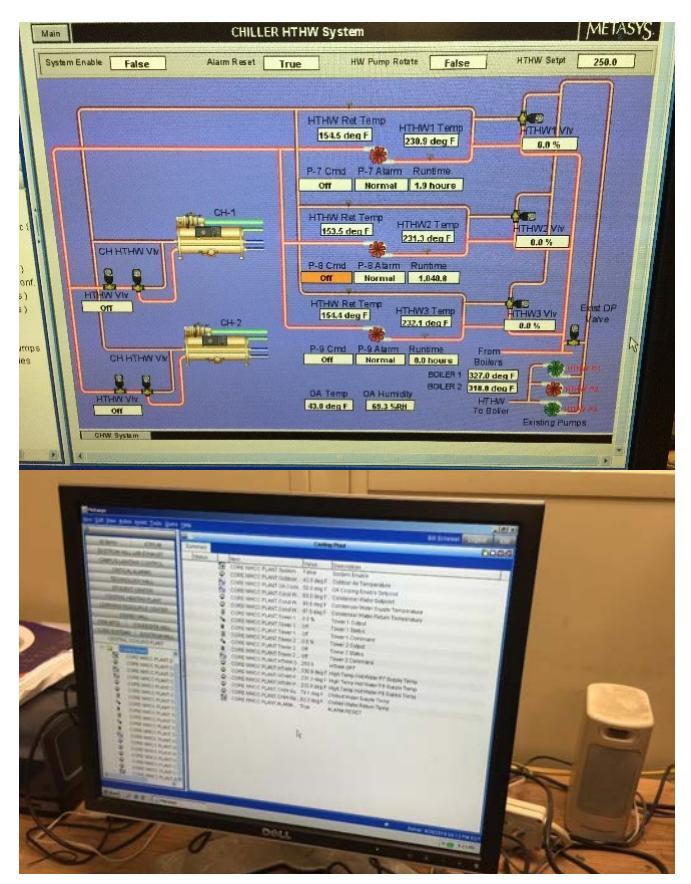
FIGURE 2.2: Energy Use Information Management System

The campus' building automation system (BAS) is Johnson Controls Metasys. System capabilities include adjusting lighting controls, HVAC set points, and monitoring Central Plant alarms. Lately, Facilities has been experiencing software glitches causing the unscheduled shutdown of chillers, creating a need for an upgraded BAS. They explored updating the BAS in 2009, but the \$50,000 cost for the upgrade was not achievable at the time.

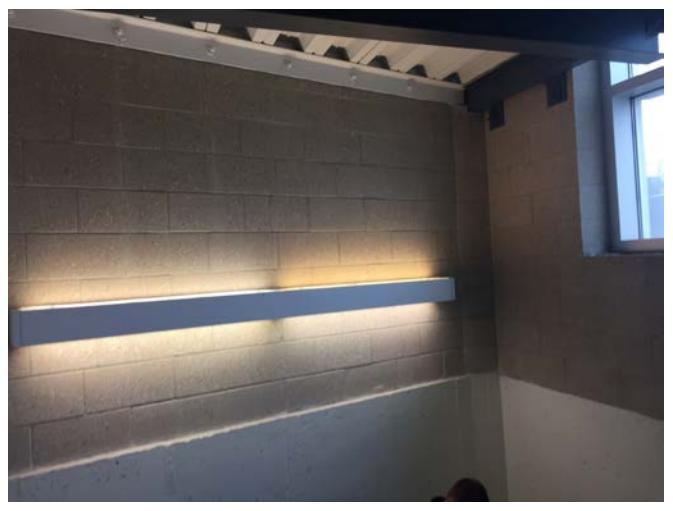
FIGURE 2.5: Indoor Lighting

Lighting fixtures across Naugatuck varies by building. Kinney Hall and the AS&L have mainly T8s without sensors. Technology Hall has T-5s, with inadequately working controls, as well as approximately 30 150W halogens on timers.

As demonstrated in the picture below, the garage lighting is controlled remotely with the BAS. Facilities has noted there has been issues with photosensor reliability.

- Install switches with occupancy sensors and recommission existing lighting and controls in Technology Hall to address faulty controls. Rewire to add controls or switches.
- Replace HPS exterior Lighting around the student center with LED
- Replacement of Halogen lighting in Technology Hall with LEDs
- Use of lighting controls with occupancy sensors in ASL
- Evaluate replacing high intensity lighting in greenhouse with LED lighting.

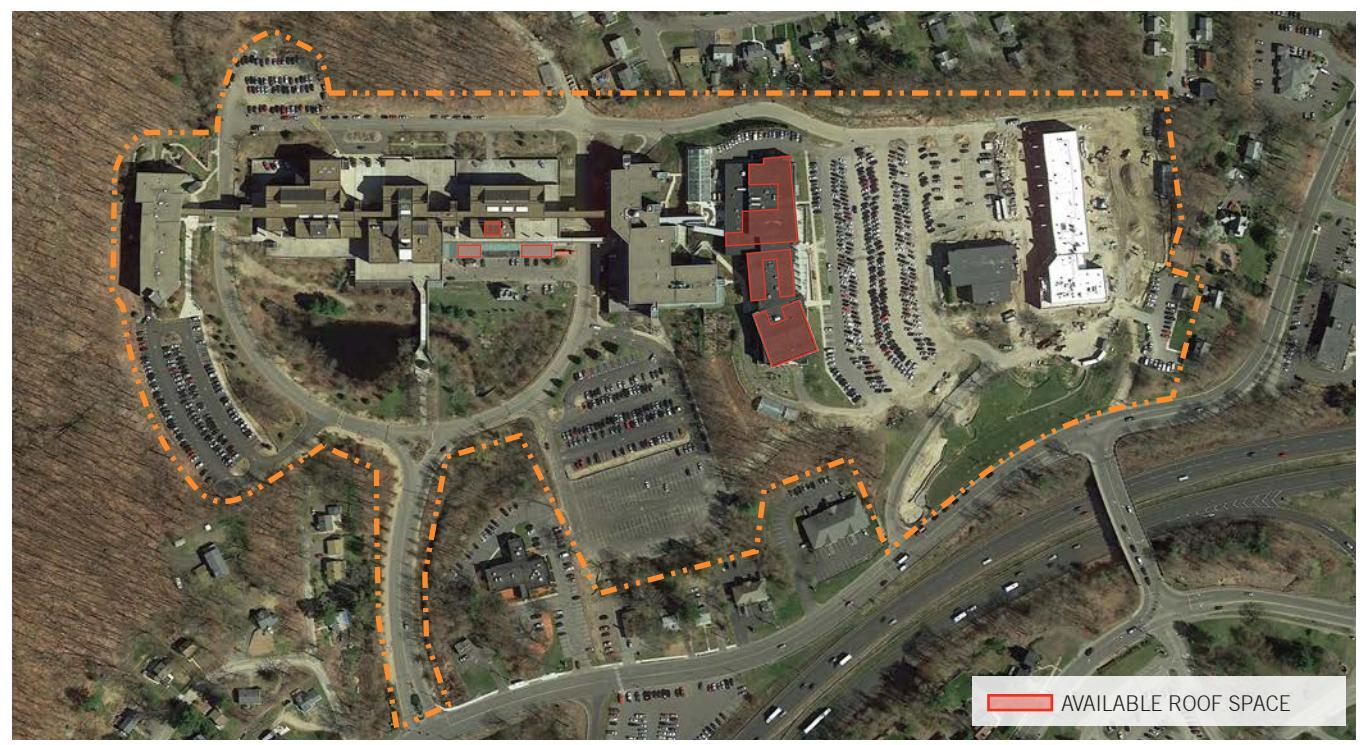
FIGURE 2.7: Naugatuck Campus PV Potential

Roof Area size based on Google Earth calculated area of solar outlines. Assumes that each sf of panels can generate between 4.6 and 6 Watts DC (about a third of the PVWatt Output Assumptions. Actual generation values would be calculated if a solar PV study was performed.
 Roof Area size based on Google Earth calculated area of solar outlines. Assumes that each sf of panels can generate between 6 and 7.7 kWh annually (about a third of the PVWatt Output Assumptions). Actual generation values would be calculated if a solar PV study was performed.

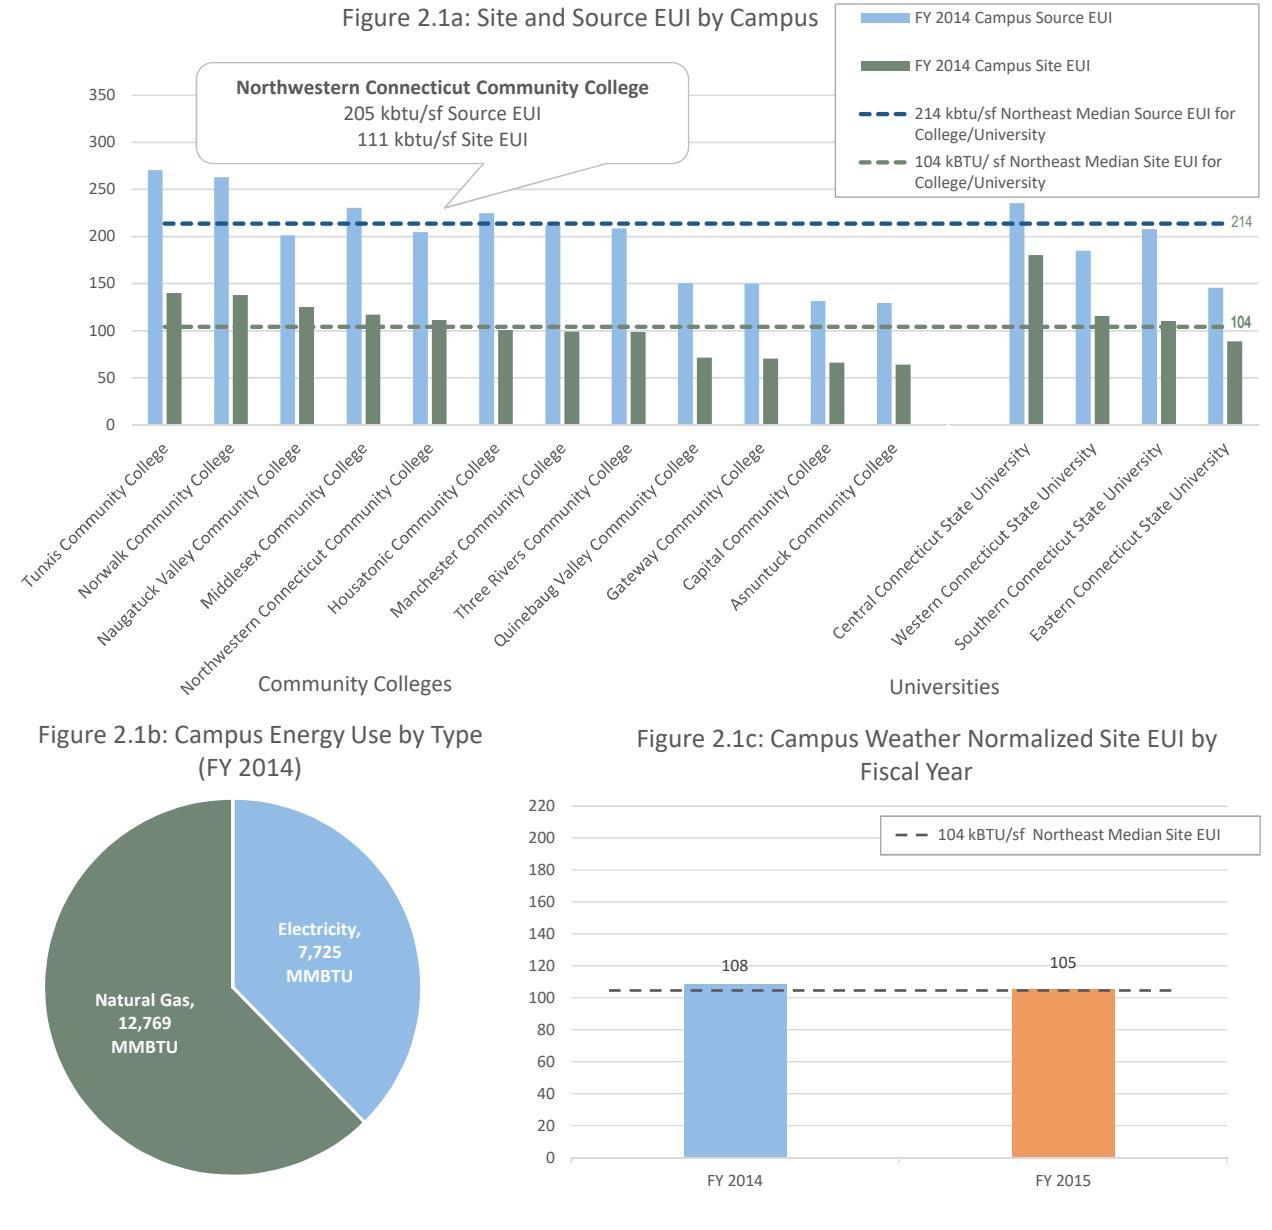
FiGURE 2.1: Northwestern Connecticut Community College Energy Dashboard

The Figure 2.1 provides a summary of Northwestern's energy use for FY14, using the data sources documented in Appendix A. Northwestern's site EUI is the fifth highest of the 12 CSCU community colleges, with a site EUI of 111kbtu/sq ft. In comparison to the Northeast median site EUI for colleges/universities, it is only slightly higher.

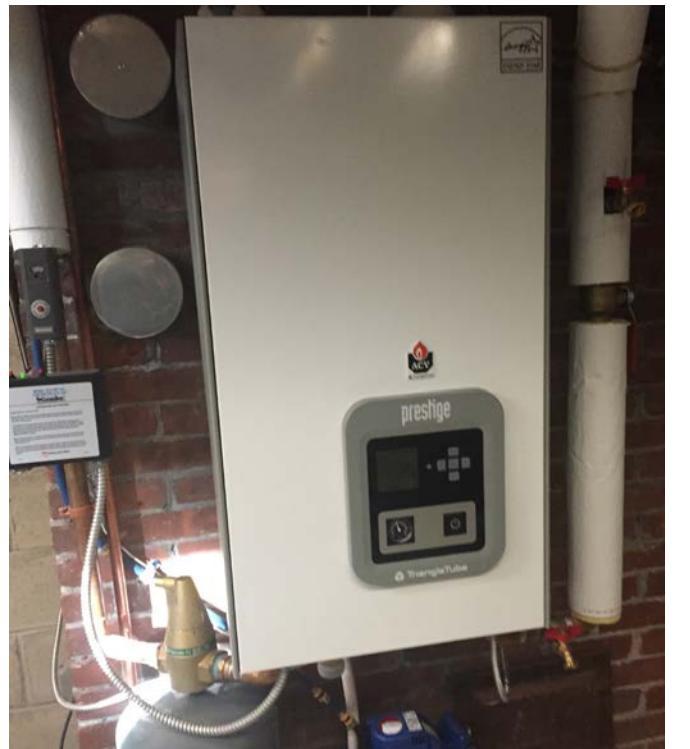
FIGURE 2.5: Northwestern Boiler System

Residential sized direct vent condensing natural gas boilers with integral domestic hot water heaters were installed in 2015 in the English Building, Goulet Building, and Administration Building. The higher efficiency expected from the new boilers is not reflected in the 2014 EUI.

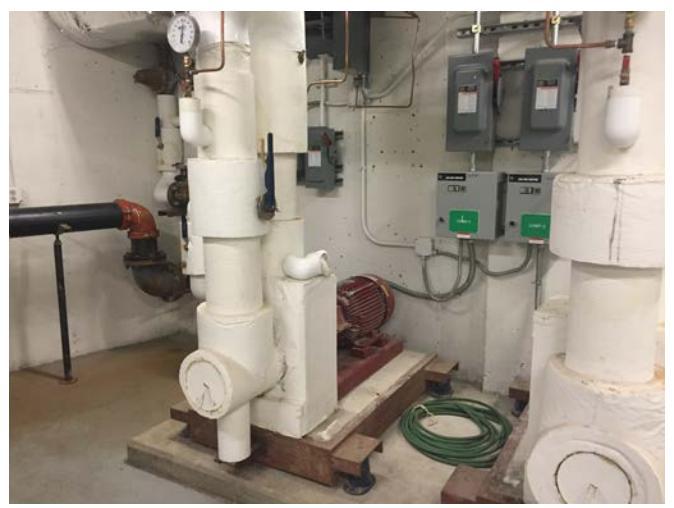
FIGURE 2.6: Chiller System

The Art and Science Center houses a 140 Ton chiller, located in the basement and is original to the building in 2007.

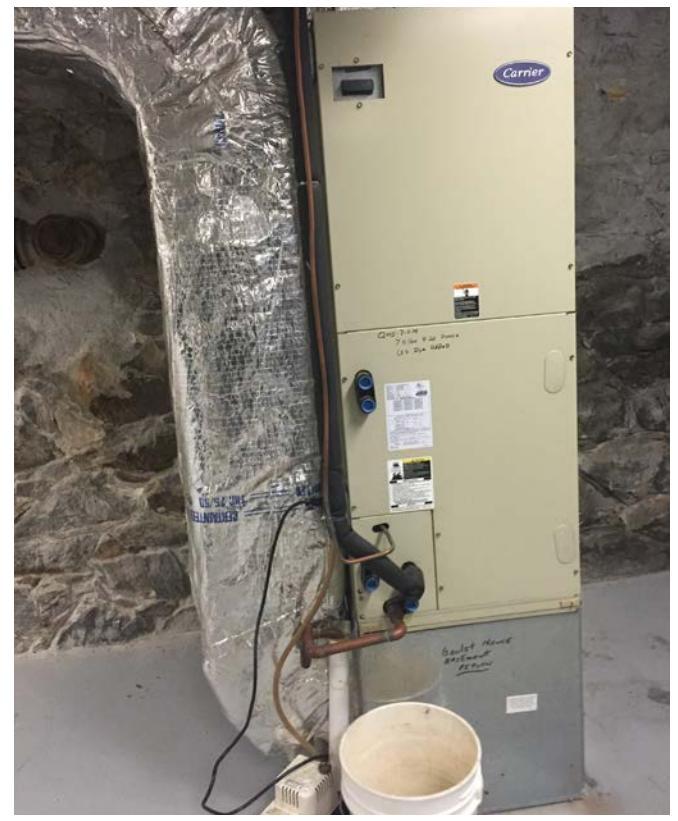
FIGURE 2.7: Trane XE 80

Trane XE 80 furnaces in the basements of the old residential buildings are also used for heat. The gas burners are only about 80% efficient where the condensing wall mounted units are well over 90%. It is unknown what percentage of the building heat is provided by the boiler versus the furnace.

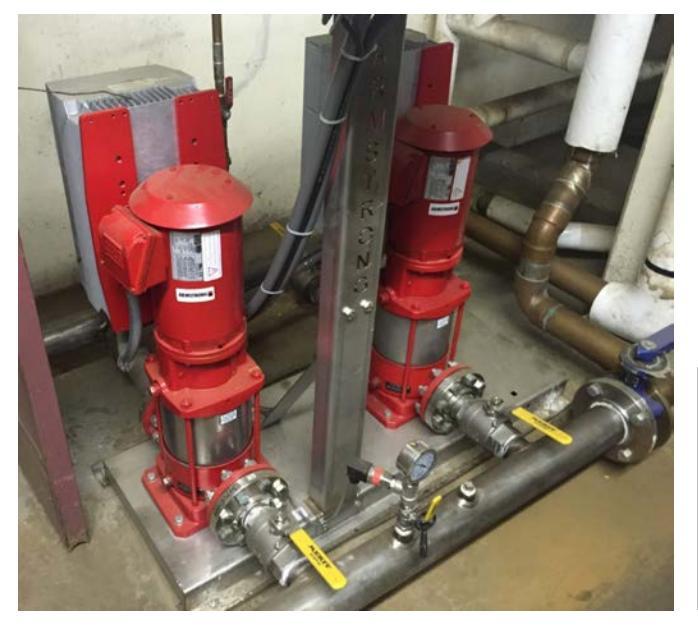
FIGURE 2.3: Pre-packaged VFD pump system by Armstrong International

A pre-packaged VFD pump system by Armstrong International offers high efficiency pumping.

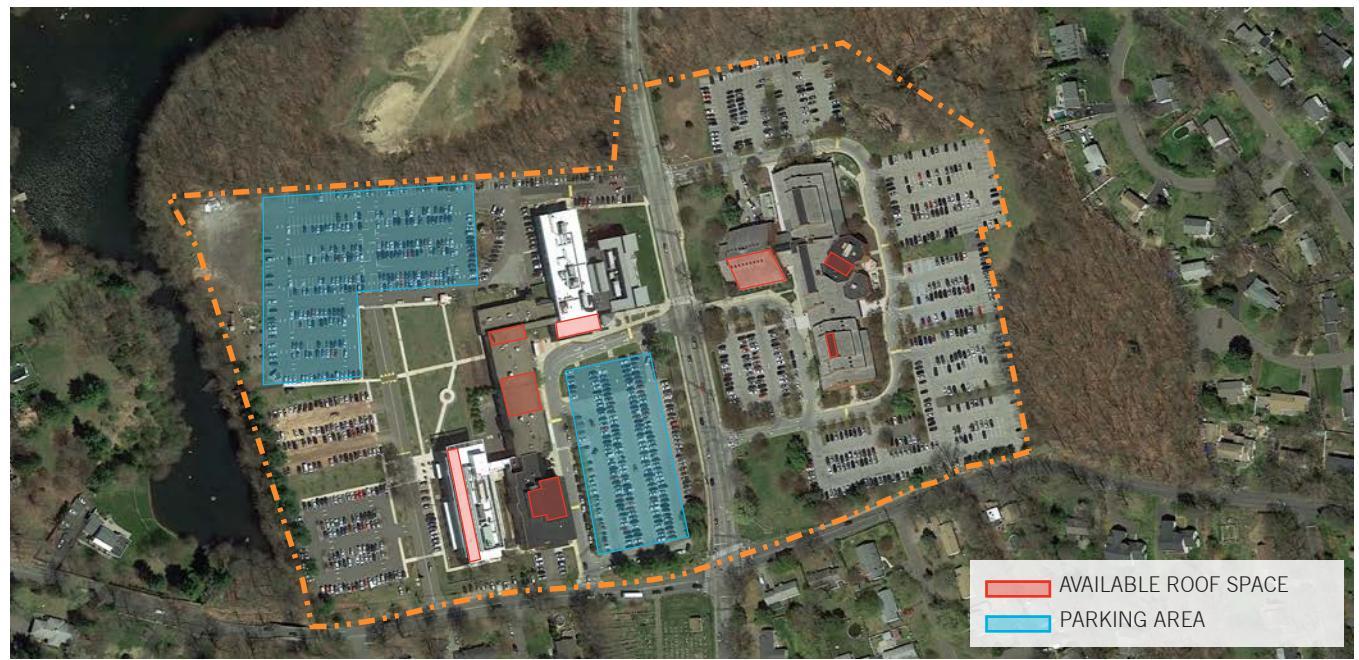
FIGURE 2.5: Norwalk Campus PV Potential

[1] Assumes that each si of panels can generate between 6 and 7.7 kWh annually (about a third of the PVWatt Output Assumptions). Actual generation values would be calculated if a solar PV study was performed.

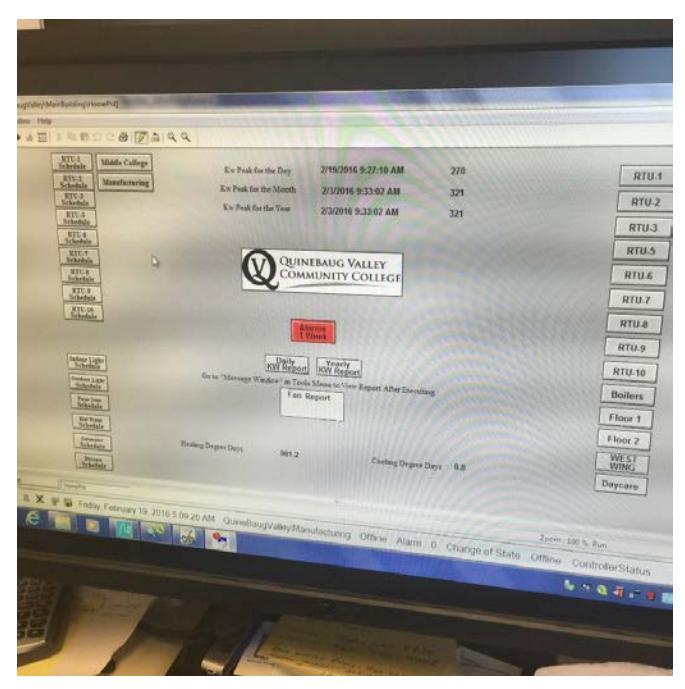
FIGURE 2.2: Energy Management System

Quinebaug also uses an energy management system for monitoring energy consumption. Currently, most of the BMS's functions are operated manually and require frequent interaction from the operator to run optimally. While the current dedicated staff are doing exemplary work and successfully reducing energy by manually managing the BMS functions, it is a concern that this is not a long-term model. It is an individual-centric system that is likely not sustainable with an unexpected change in staffing.

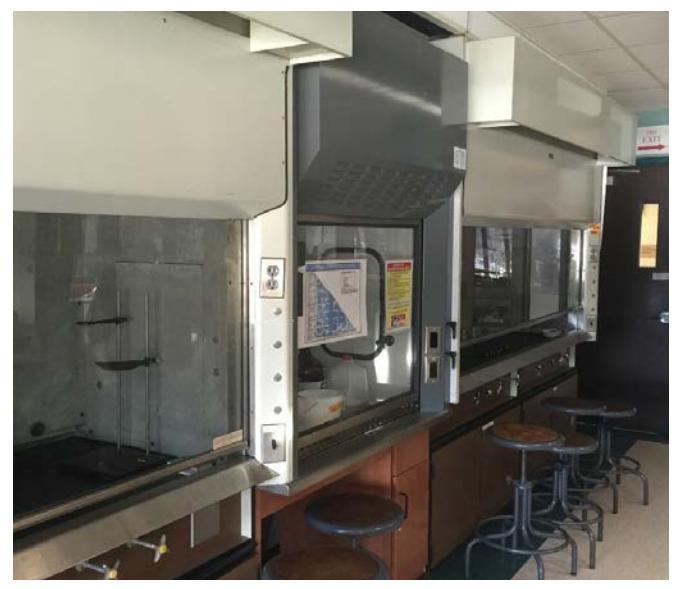
FIGURE 2.4: Fume Hoods

Fume hoods were observed to have varying degrees of use. Some sashes were properly closed, while others were half opened and unused. In some cases, fume hoods were observed to be used for paperwork or storage for faculty.

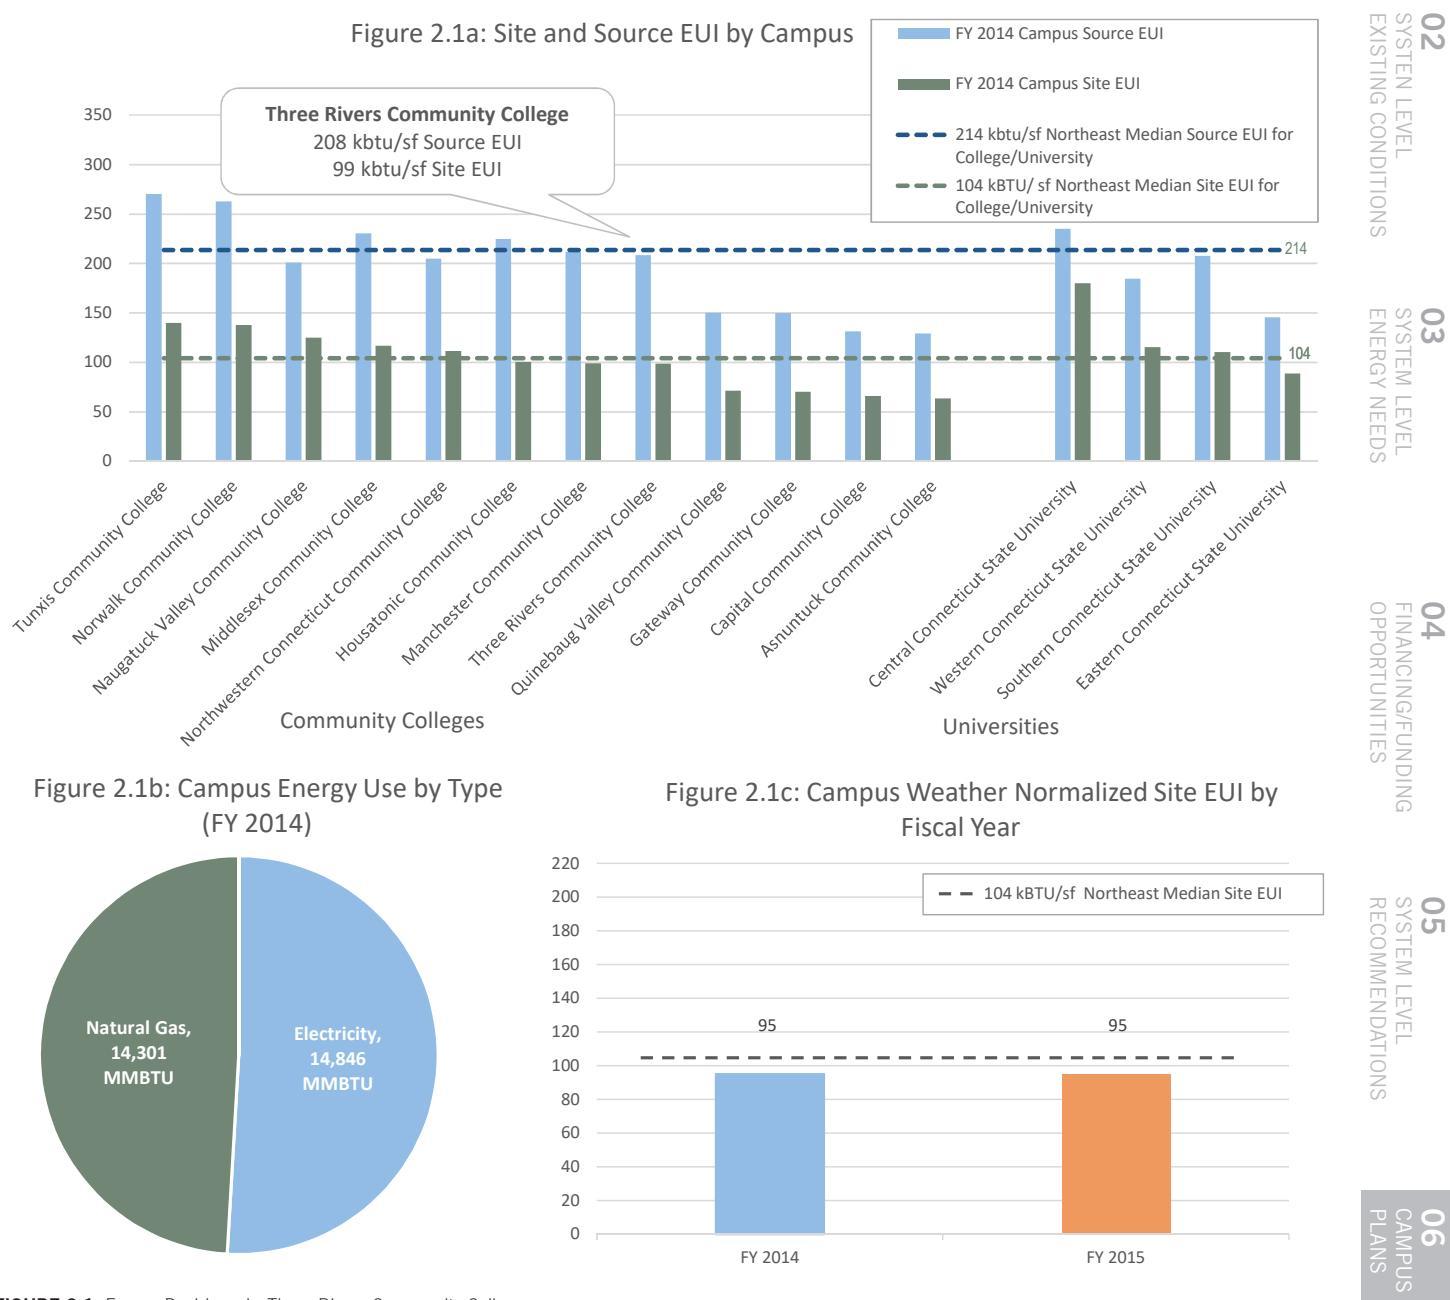
FIGURE 2.1: Energy Dashboard - Three Rivers Community College

Figure 2.1 provides a summary of Three Rivers' energy use. Appendix A documents information on the assumptions and data sources used for energy benchmarking purposes. Three Rivers' site EUI of 99 kbtu/sq ft is below the Northeast median of 104 kbtu/sq ft for colleges/universities. 01 INTRODUCTION

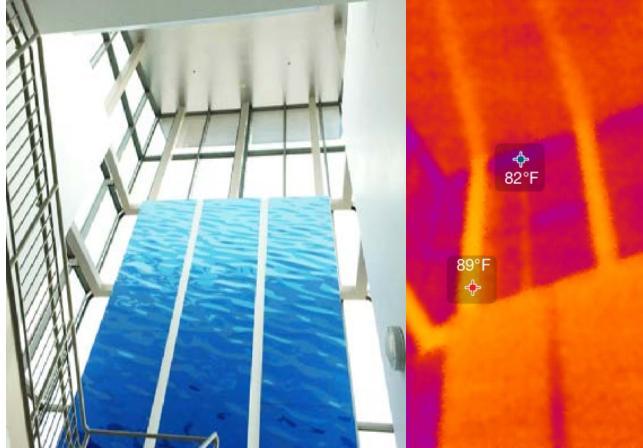
FIGURE 2.7: Clock tower and infrared version showing temperature stratification more than 10 degrees higher than the setpoint

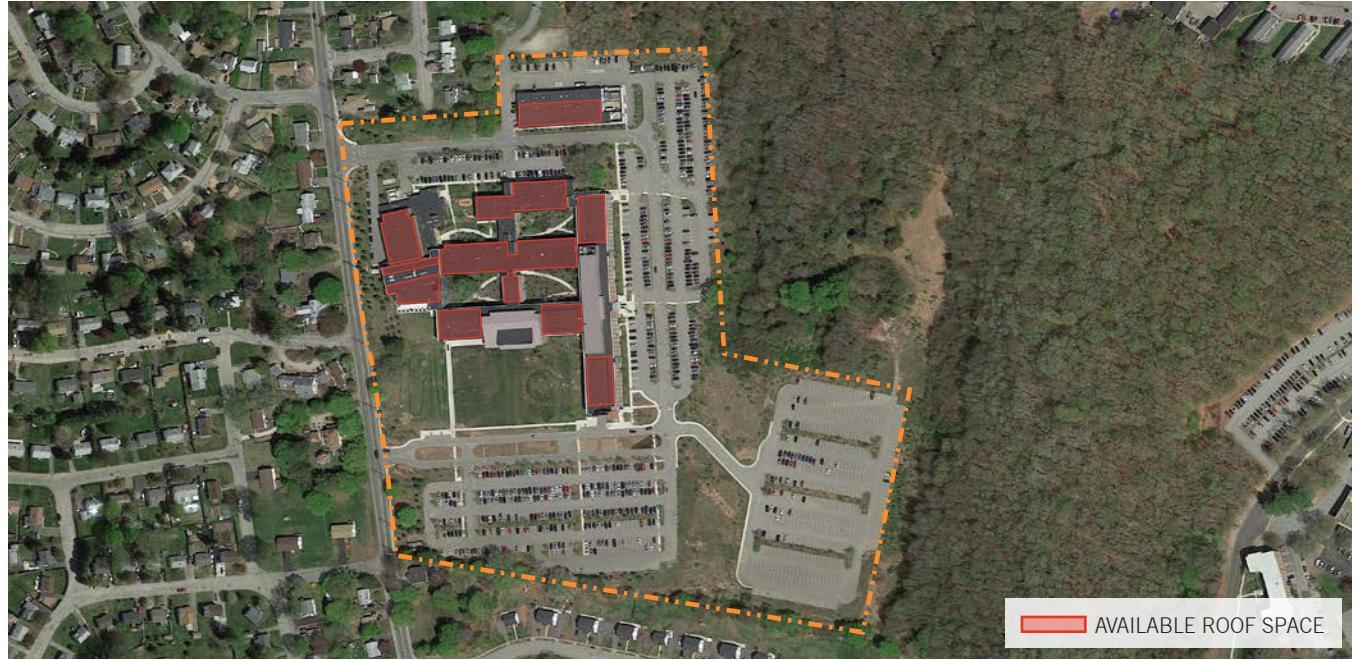
FIGURE 2.8: Three Rivers Campus Solar Potential

[2] Assumes that each sf of panels can generate between 6 and 7.7 kWh annually (about a third of the PVWatt Output Assumptions). Actual generation values would be calculated if a solar PV study was performed.
